# Stresses in several types of bridges, May 1975, M.S. thesis

A Thesis

Civil Engineering

May 1975

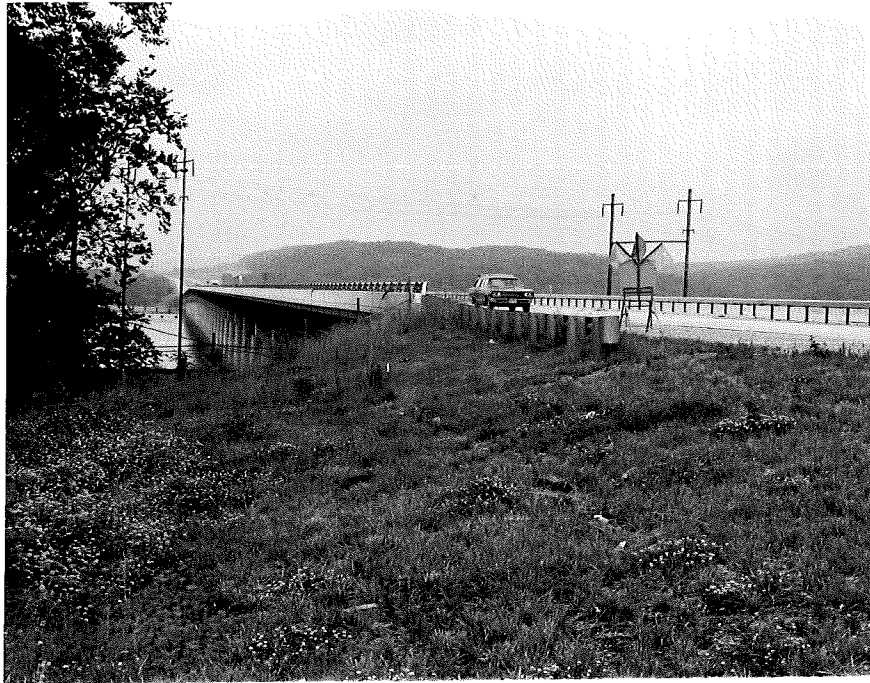
Fig. 1 Columbia-Wrightsville Bridge

The Columbia-Wrightsville Bridge, Fig. 1, consists of twin bridges which carry the east and west bound lanes of Pa. 462 over the

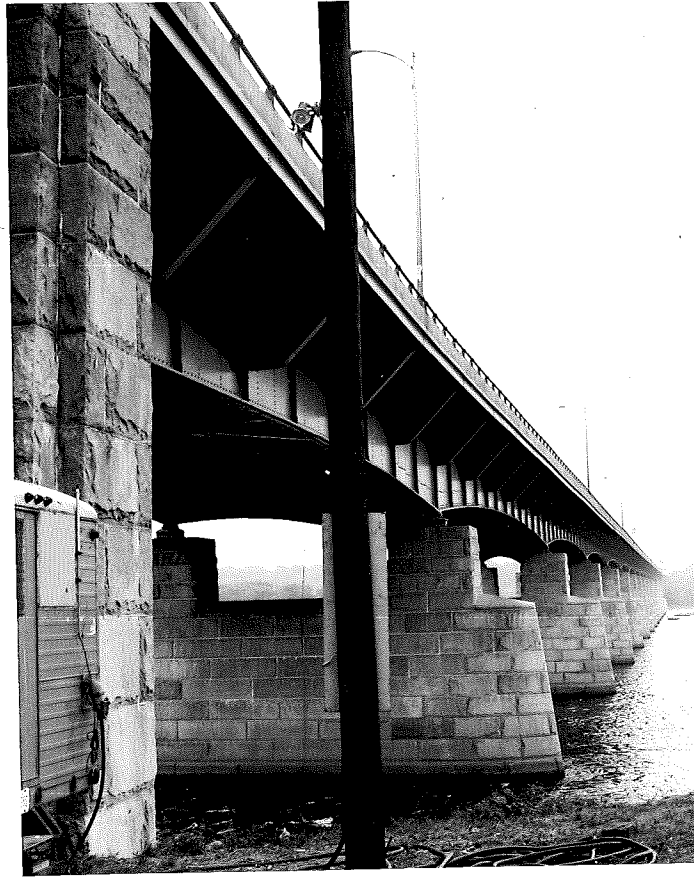
Fig. 6 South Bridge

The South Bridge in Harrisburg, see Fig. 6, consists of a 20-span continuous girder bridge and six approach spans. <sup>NORTH</sup>~~East~~ and <sup>SOUTHBOUND</sup>~~westbound~~ lanes are on the same superstructure. The east end span was investigated because of its accessibility.

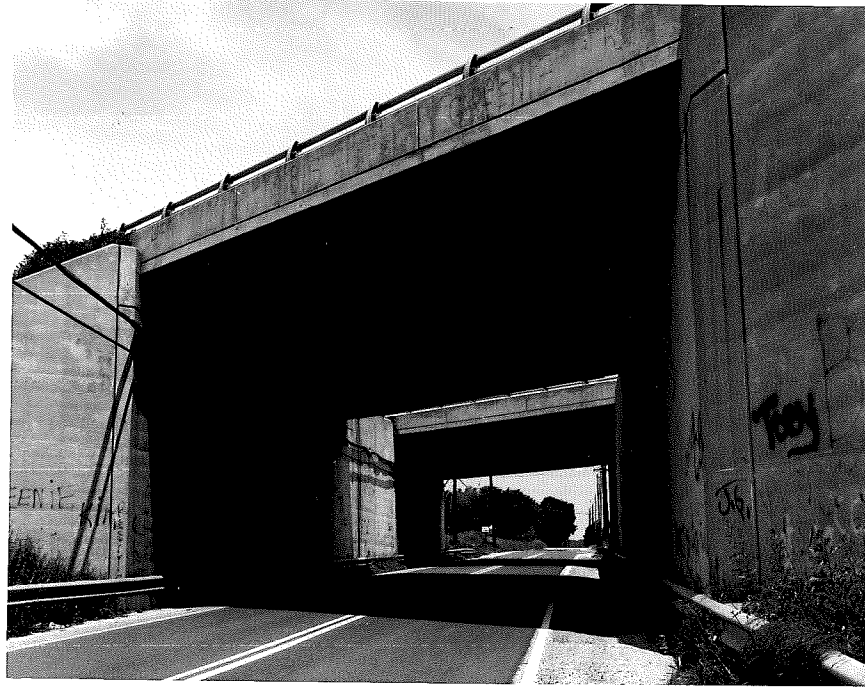
Fig. 9 West Chester Bridge

The West Chester Bridges, Figs. 9 and 10, carry the north and southbound lanes of U. S. Route 202 over Green Hill Road near West Chester, Pennsylvania. These short, skewed, coverplated beam bridges consist of seven simply supported beams (W27 x 84) composite with an 8" reinforced concrete deck and braced by diaphragms (C15 x 33.9). These failures occur primarily in the rivets connecting the first inbound stringer and the tieplate to the floor beam, or in some cases in those rivets connecting the girder to the tieplate. The west view and cross section of one of the bridges are shown in Fig. 11. A plan view of both bridges (without the concrete deck) is sketched in Fig. 12. Gages were placed on the beams near midspan and at the ends of the coverplates, on the diaphragms, and at the diaphragm connection.
